ERDC/CHL TR-02-11

Periodic Inspections of Kahului and Laupahoehoe Breakwaters, Hawaii

Armor Unit Monitoring for Period 1992/93-2001

August 2002

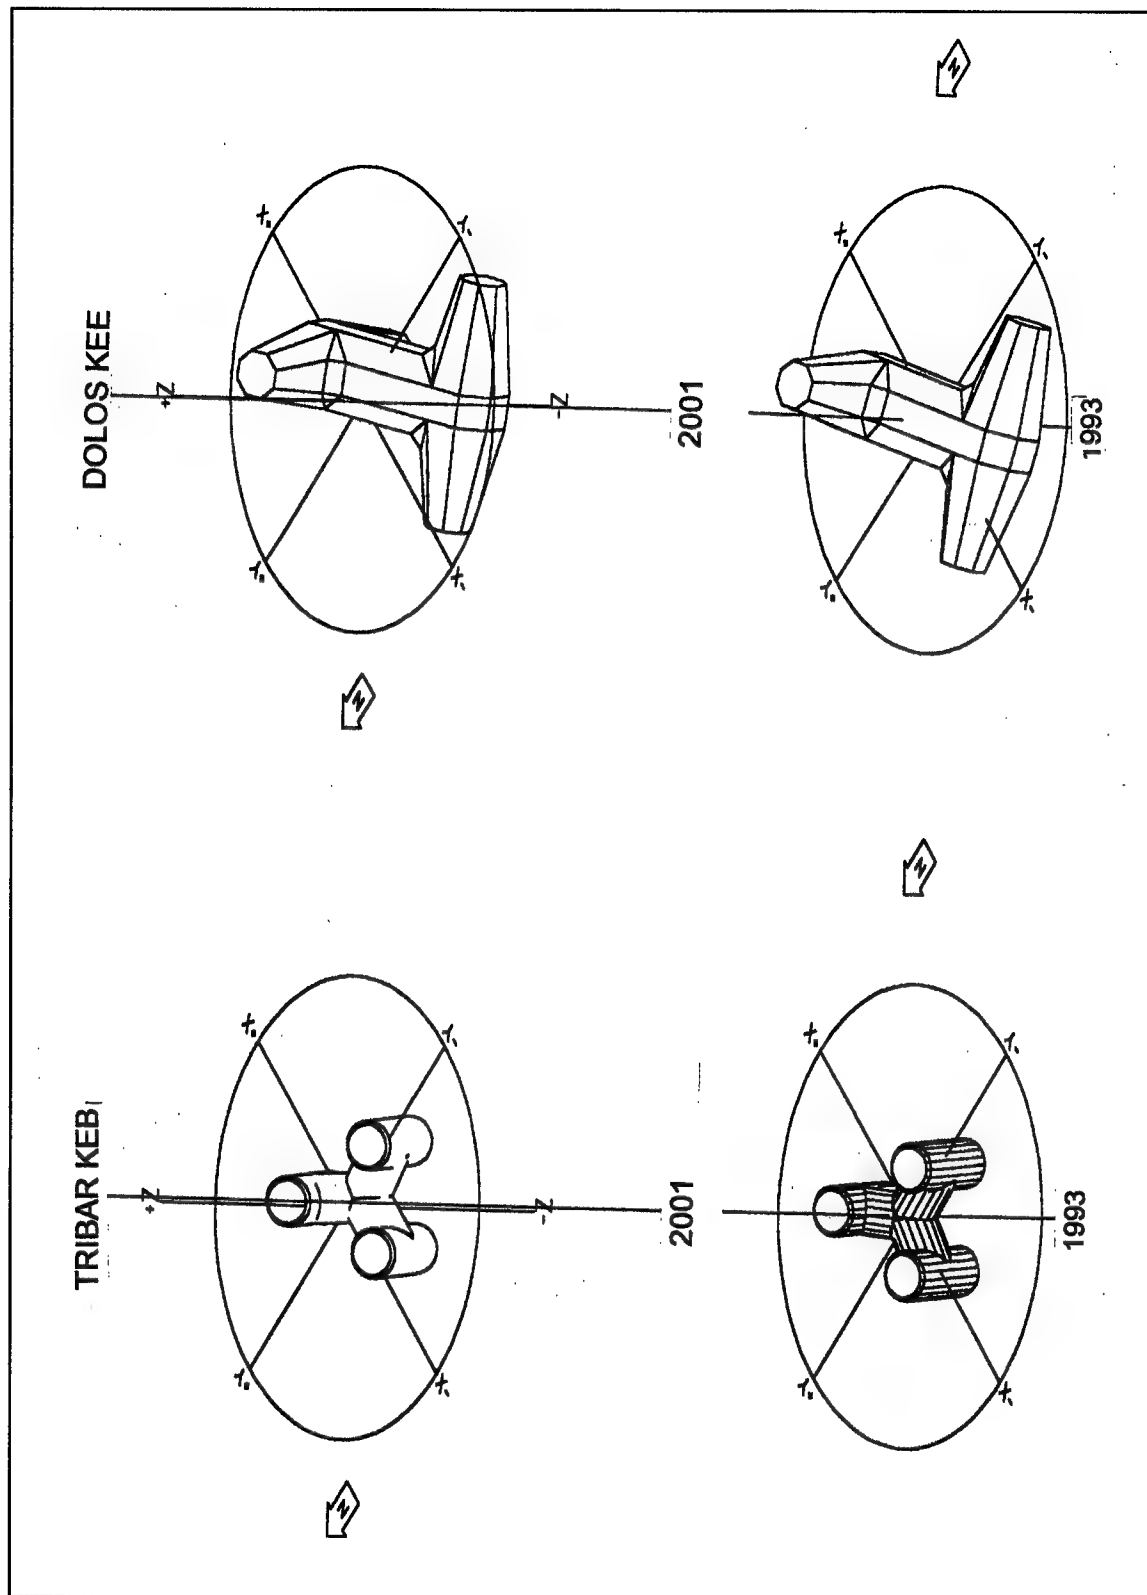
Figure 22. Comparison of representative targeted armor unit position relative to x, y, and z axes

With the x, y, and z (easting, northing, and el) coordinates defined for each target on the various armor units, the coordinates of the centroid (center of mass) of each targeted armor unit were computed for the 2001 aerial survey. In addition, the position of each armor unit relative to the x, y, and z axes was determined and compared with previous data. Figure 22 shows, in three dimensions, the orientation and comparison of representative armor units to the three axes for the two surveys. The centroid coordinates of each targeted armor unit on the Kahului east and west breakwaters and the Laupahoehoe breakwater are shown in Tables 5-7 and compared with the aerial survey results of 1992/1993. Maximum movement of the centroids for the Kahului east breakwater was 0.536 m (1.76 ft) and 0.671 m (2.2 ft) in the horizontal and vertical directions, respectively, while average movements were 0.119 m (0.39 ft) and 0.17 m (0.57 ft) in the horizontal and vertical directions. As noted earlier, data were not obtained for two targets (KED1 and KEE2) on the Kahului east breakwater, however, based on information available and known dimensions of these armor units, their centroid positions were calculated. For the Kahului west breakwater, maximum horizontal and vertical centroid movements, respectively, were 0.64 m (2.1 ft) and 0.186 m (0.61 ft), while average movements were 0.113 (0.37 ft) and 0.64 m (0.21 ft) in the horizontal and vertical directions. Maximum movement of the centroids for the Laupahoehoe breakwater was 0.091 m (0.3 ft) and 0.085 m (0.28 ft) in the horizontal and vertical directions, respectively, while average movements were 0.03 m (0.1 ft) and 0.034 m (0.11 ft) in the horizontal and vertical directions. The targeted armor units' orientation (rotation angle relative to the x, y, and z axes) are presented in Tables 8-10 for the east and west Kahului breakwaters and the Laupahoehoe breakwater and compared with the aerial survey results of 1992/1993. For the Kahului east breakwater, changes in the rotation angle of the targeted armor units varied from 0.03 to 24.57 deg with an average of 3.09 deg. Changes in rotation angles varied from 0.0 to 17.32 deg for the Kahului west breakwater with an average of 2.02 deg. For the Laupahoehoe breakwater, changes in rotation angles varied from 0.01 to 0.36 deg with an average of 0.1 deg.

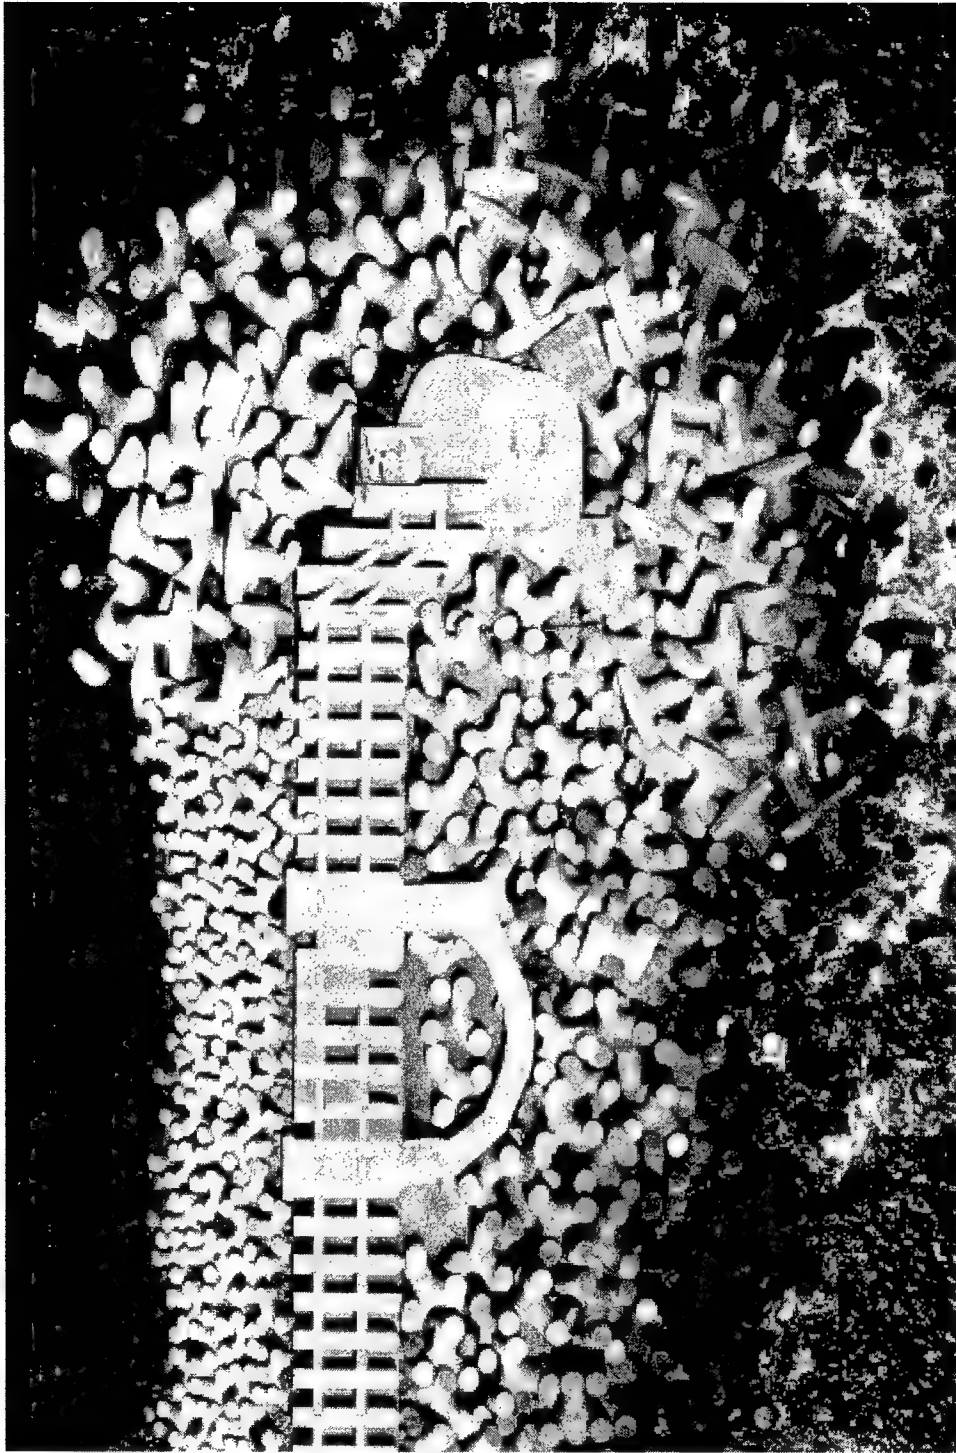
Figure 23. Photo map of head of Kahului east breakwater

Photo maps combine the image characteristics of a photograph with the geometric qualities of a map. The image is rectified and free from skewness and distortion, and therefore, precise horizontal measurements may be obtained using an engineer scale. Photo maps were prepared for the outer portions of the Kahului east and west breakwaters and the Laupahoehoe breakwater for the 2001 survey. They were produced on mylar sheets at a scale of 1:240. Examples of photo maps for the Kahului east and west breakwater heads and the Laupahoehoe breakwater are shown in Figures 23-25. In an effort to quantify horizontal movement of nontargeted concrete armor units on the Kahului and Laupahoehoe breakwaters, photo maps obtained for the 1992/1993 and 2001 were compared. Eight 27,215-kg (30-ton) dolosse around the seaward quadrant of the head of the Kahului east breakwater (including targeted units KED and KEE) appeared to have slightly changed positions. Movement appeared to be on the order of 0.3 to 0.9 m (1 to 3 ft). These units have not broken and are considered functional. Just a few additional units on the remaining portion of the Kahului east breakwater, as well as on the Kahului west breakwater, had moved slightly with no concentrations in any specific areas. Negligible movement of nontargeted units on the Laupahoehoe breakwater was detected between the surveys.

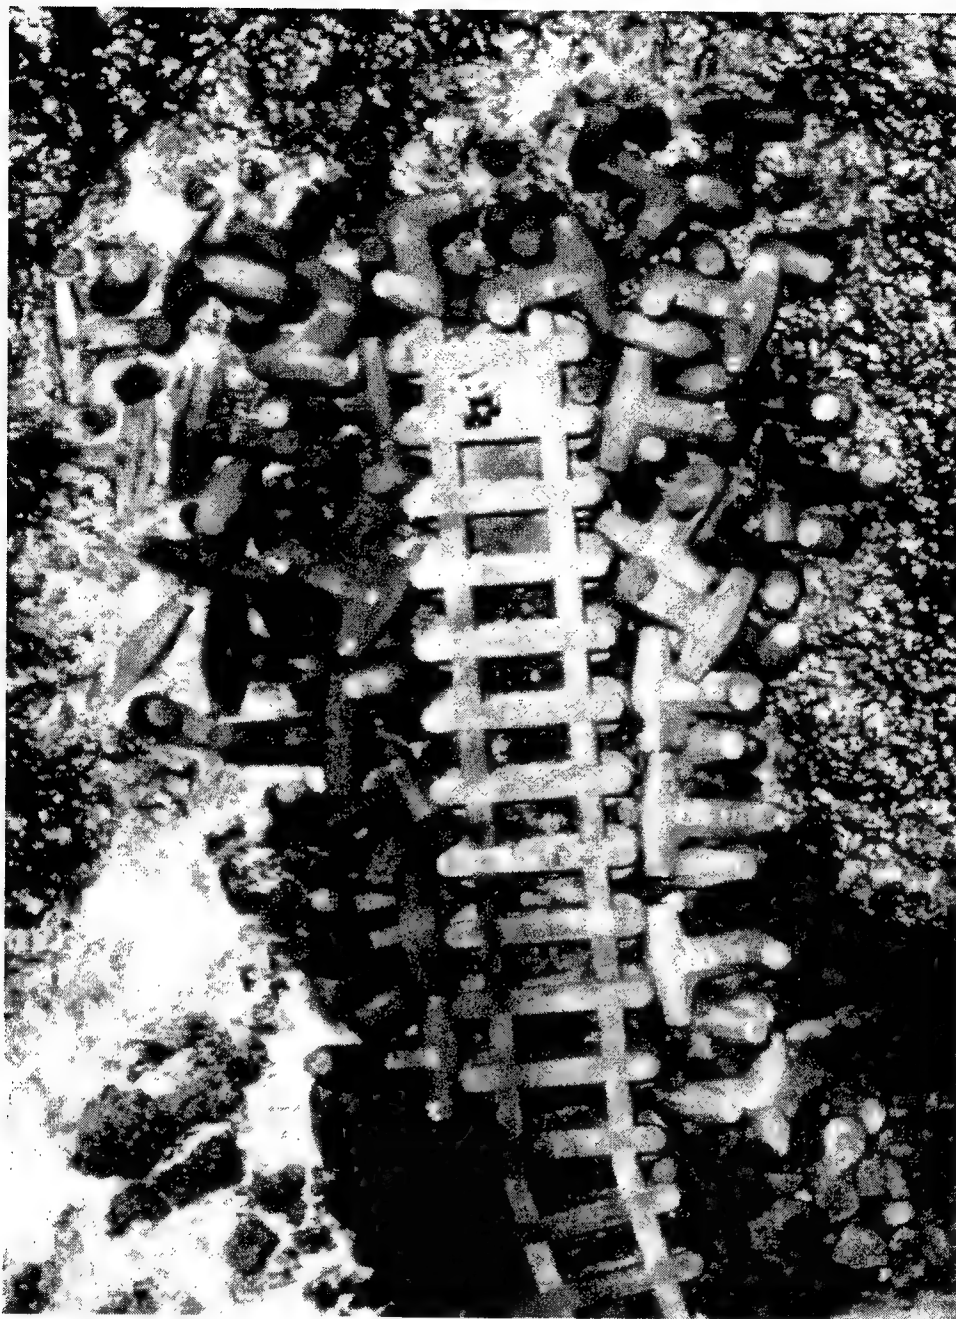
Figure 25. Photo map of Laupahoehoe breakwater

29 broken or cracked armor units were identified and 58 were observed on the Kahului west breakwater during the walking survey. No broken or cracked armor units were found on the Laupahoehoe breakwater .
